## The value of piston rod vibration measurement in reciprocating compressors

by **Larry Leonard**  
Senior Reliability Engineer  
UNOCAL 76 Products Company  
San Francisco Refinery

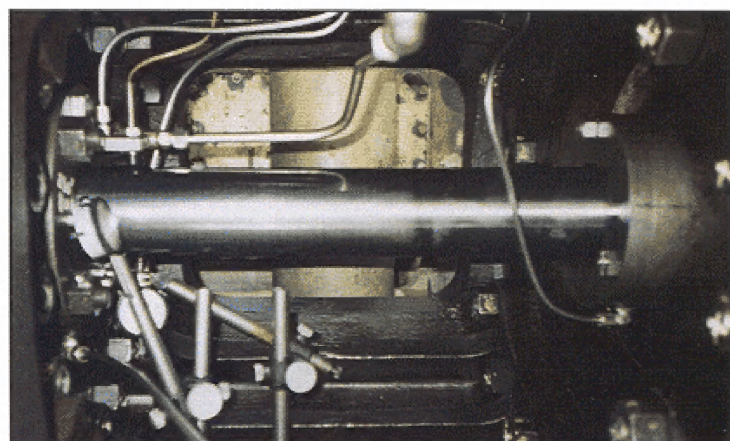
Figure 2  
Rod Drop proximity probe installation.

There was some concern that the proximity probe might be coming loose, so the access cover on the distance piece was removed and the bracket checked. The probe installation was satisfactory, however, we observed excessive piston rod motion.

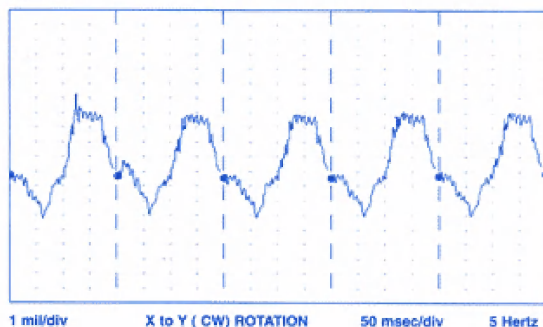
Figure 3

August 31: Rod Drop proximity probe unfiltered waveform, with normal shape.

Data was gathered on the machines every two to four weeks to assess machine condition. The rod drop vibration waveform from August 31 (Figure 3) was typical. It was sinusoidal with a frequency of 300 cpm, the running speed of the machine.

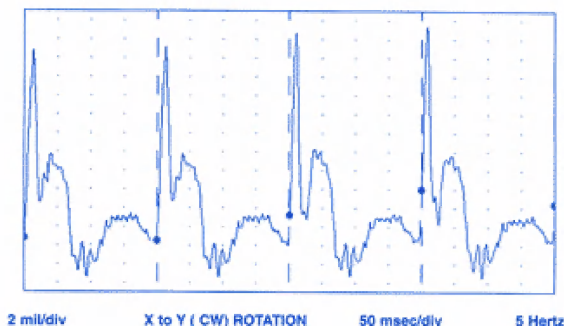
Figure 4

October 4: Rod Drop proximity probe unfiltered waveform. Spikes in the waveform had become more pronounced.

In early October, a disturbing trend developed on the 1st Stage number 2 cylinder of unit G203B. Comparison of the unfiltered waveform plots from August 31 (Figure 3) and October 4 (Figure 4) indicated that both vibration amplitude and waveform shape had changed significantly. The amplitude started at 229  $\mu\text{m}$  (9 mils) pp and, by October 4, had increased to 630  $\mu\text{m}$  (24.8 mils) pp. The October 4 waveform contained sharp spikes.

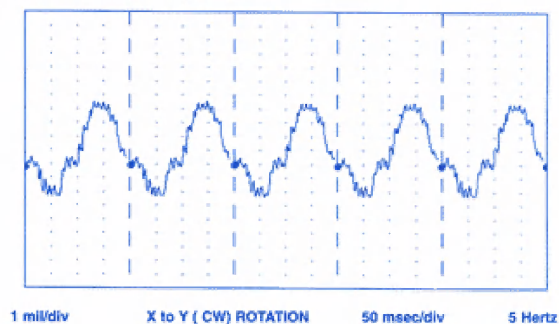
Figure 5

October 9: Rod Drop proximity probe unfiltered waveform. The waveform's shape had returned to normal.

Data acquired on October 9 (Figure 5), after the machine was put back in service, shows a vibration amplitude and form that is similar to the data acquired on 31 August (Figure 3). There was no indication of a spike on the waveform, and the vibration amplitude was 148  $\mu\text{m}$  (5.8 mil) pp.

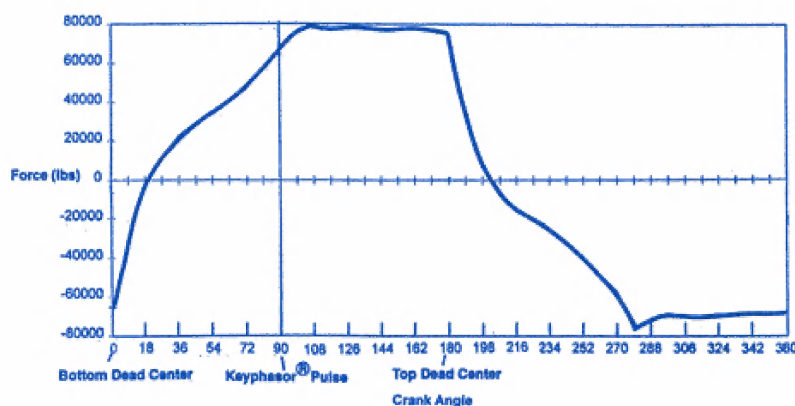
Figure 6

Waveform data was analyzed in comparison to the piston motion and Pressure Volume (PV) curves. We used the PV diagrams to calculate rod load (Figure 6) and found that the spike in the waveform occurred at the point of

maximum compressive rod load. This raised the possibility of excessive rod flexure caused by a crack. The increase in piston rod vibration was of sufficient concern that a shutdown and inspection was planned. At the very least, the high rod vibration would cause excessive packing wear.

Combined Rod Load in relation to the crank angle.

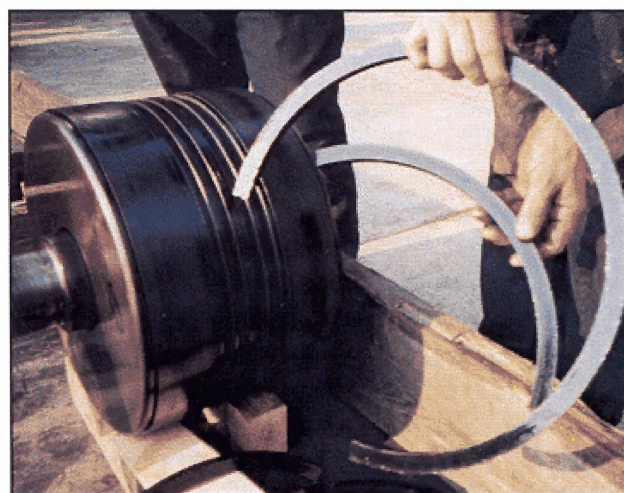
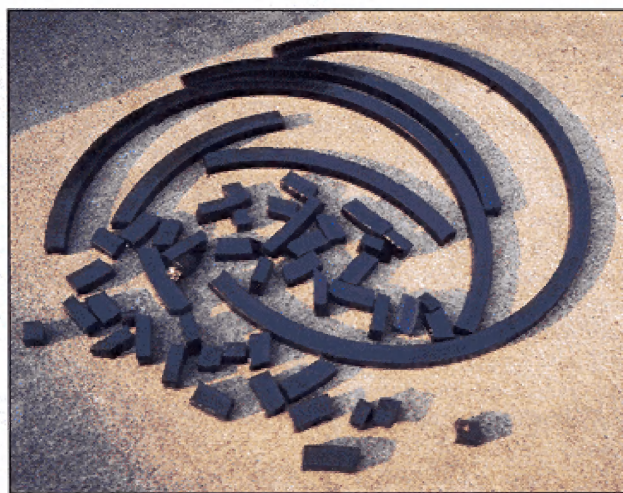
Figure 7

The primary problem noted was that all four of the piston rings were broken in numerous pieces (Figure 7). In addition, piston rod runout was 152  $\mu\text{m}$  (6.0 mils), due in part to a 63.5  $\mu\text{m}$  (2.5 mil) bow in the rod. The wrist pin bushing clearance was 241 to 254  $\mu\text{m}$  (9.5 to 10 mils), which was slightly out of tolerance — 9 n.s. was the maximum allowable clearance. Finally, a crankshaft counterweight was improperly seated on the crankshaft. These items were corrected, new piston rings installed, and the unit was put back in service.

Monitoring and trending piston rod vibration proved to be a valuable tool for assessing machine condition. Increased vibration levels were probably due to the breakup of the piston rings and the resulting uneven pressurization in the ring groove. The other problems detected probably would not have caused the observed piston rod vibration. This compressor has had similar piston ring failures in the past. An investigation is under way to determine the root cause of the failure and to design an appropriate ring

The broken rings that were removed from the 1st stage number 2 cylinder of unit G203B.
